Continental Europe Synchronous Area Separation on 8 January 2021

Interim Report

Publication date: 26 February 2021

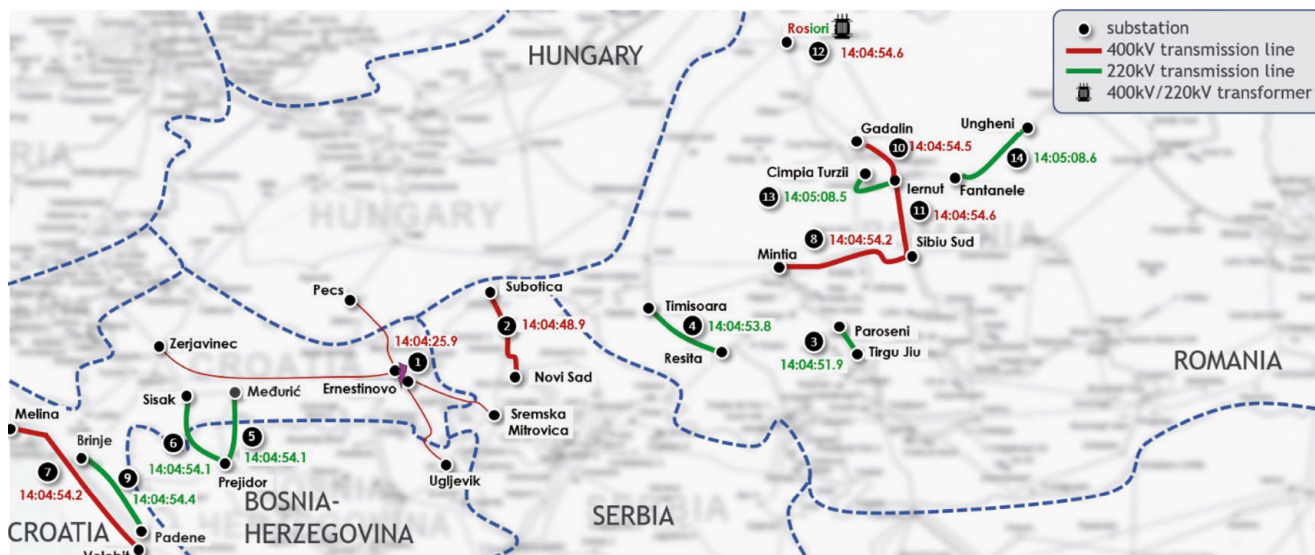
Figure 13: Geographical location of main tripped transmission system elements

The exact locations of the tripped elements in the high voltage transmission system are depicted in figure 13.

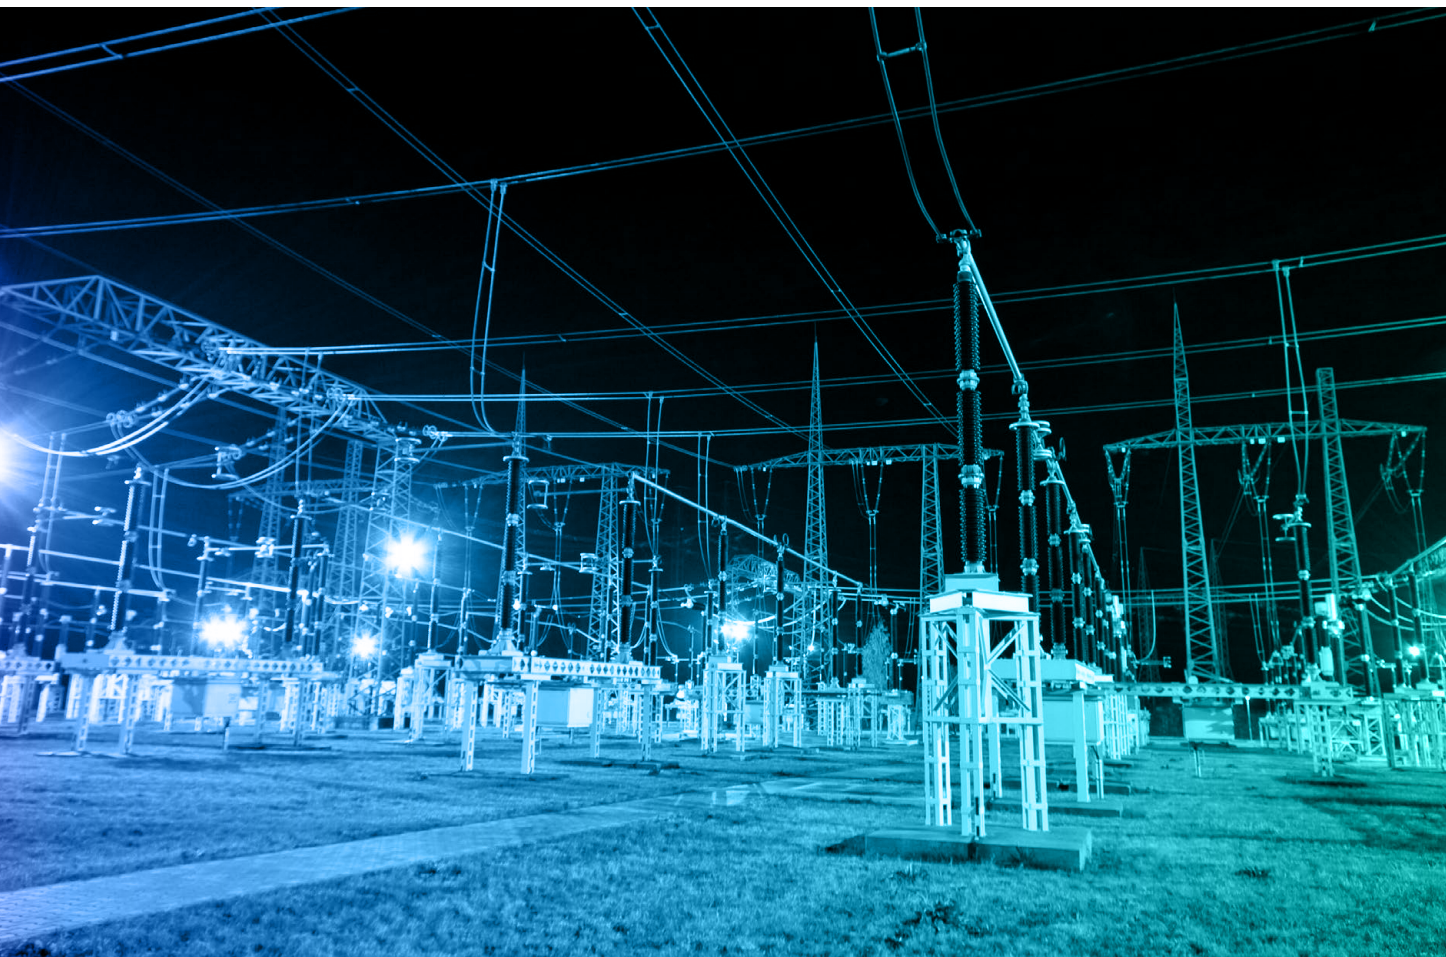
After the electrical separation, the frequency decayed very fast, with a RoCoF of 60 mHz/s, and reached its minimum at 49.74 Hz. Here a further frequency decrease was stopped by the activation of the frequency-dependent French defence system (1,300 MW reacting at 49.82 Hz) and the frequency-dependent Italian defence plan (400 MW reacting at 49.75 Hz). Both systems disconnected industrial loads regulated by dedicated contract agreements.

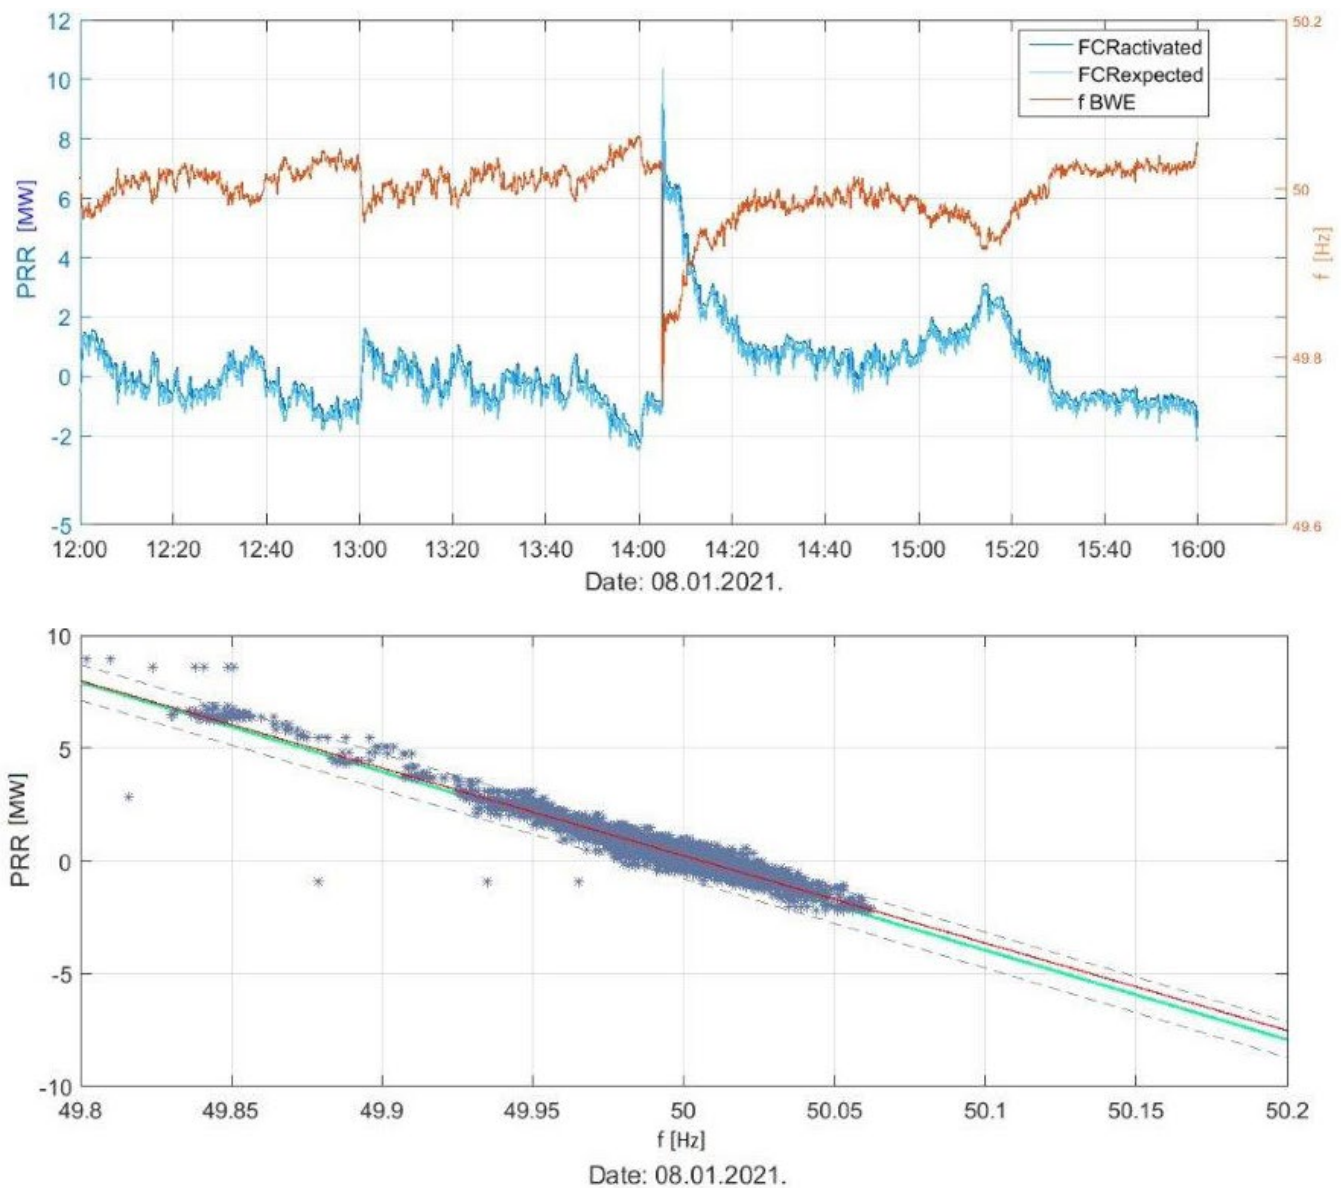
Figure 16: Activation of FCR – Provider in Austria

their generation in the South-East area. As an example, the following picture shows the almost perfect activation on 8 January of the Frequency Containment Reserve (FCR) of one provider in Austria. In the first graph it is visible how the active power output of the unit followed the frequency change. In the second graph each dot represents one working point of the unit. It is easy to conclude that the unit followed the agreed upon droop settings.

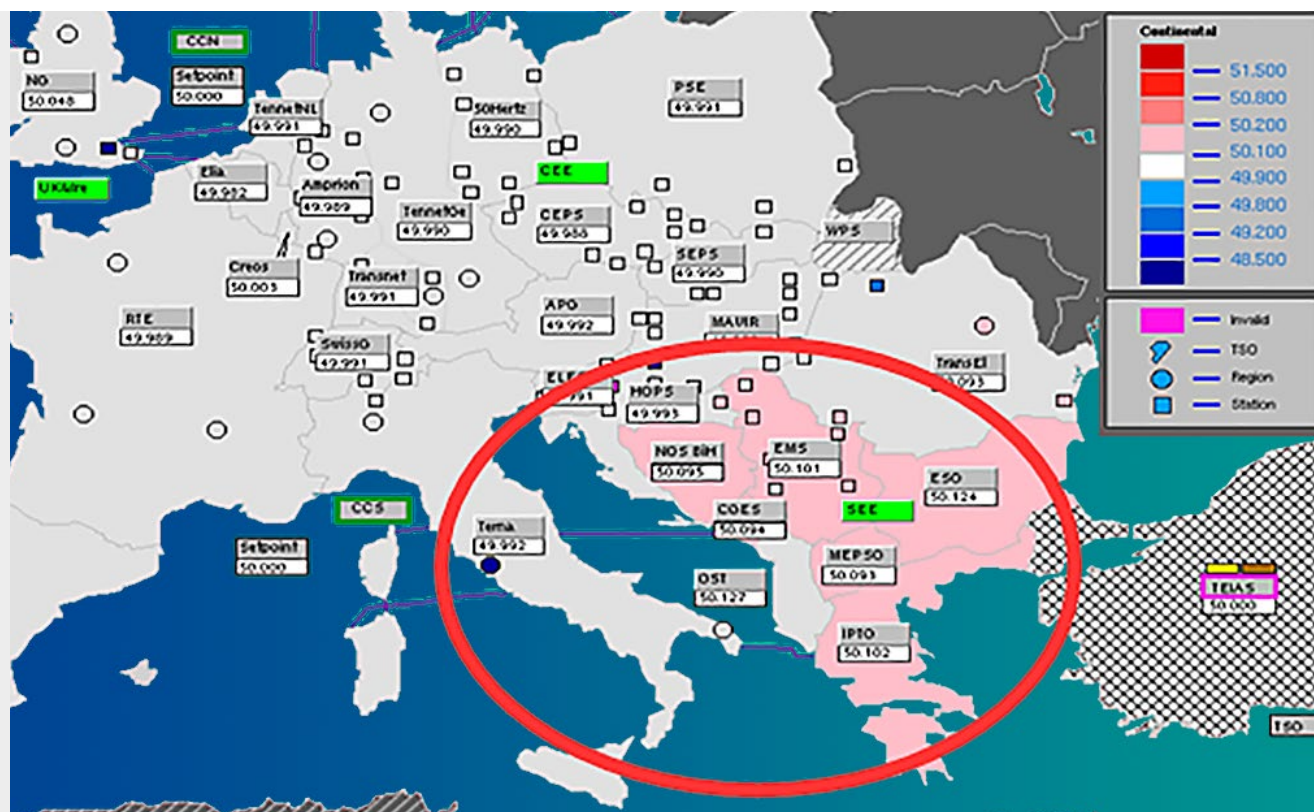
Figure 20: EAS overview of the Continental Europe Synchronous Area

(as can be observed from the frequencies, the colouring of OST is not correct in the figure because of an issue in the data handling failure in EAS).

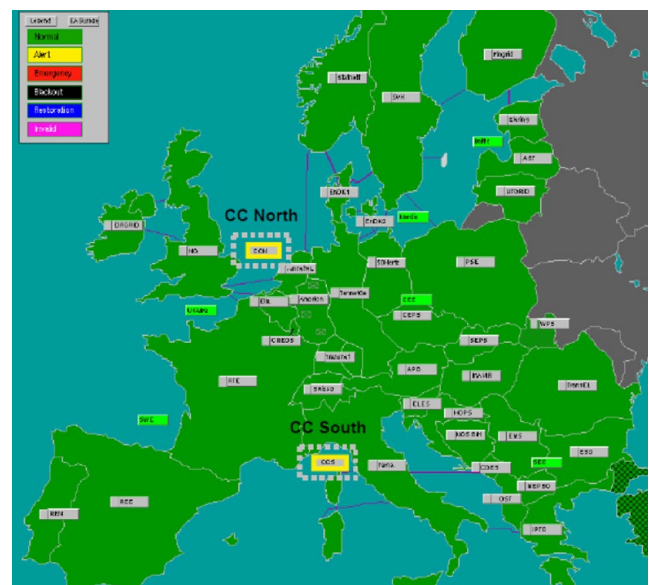
Figure 23: EAS frequency state traffic lights with status “yellow”

TSOs in case of frequency deviations. The Frequency States are triggered automatically via the local LFCs of the Coordination Centres in case of large steady-state frequency deviations and manually by operators of the Coordination Centres in case of long lasting steady state frequency deviations.
