» Continental Europe Synchronous Area Separation on 24 July 2021

Technical Report

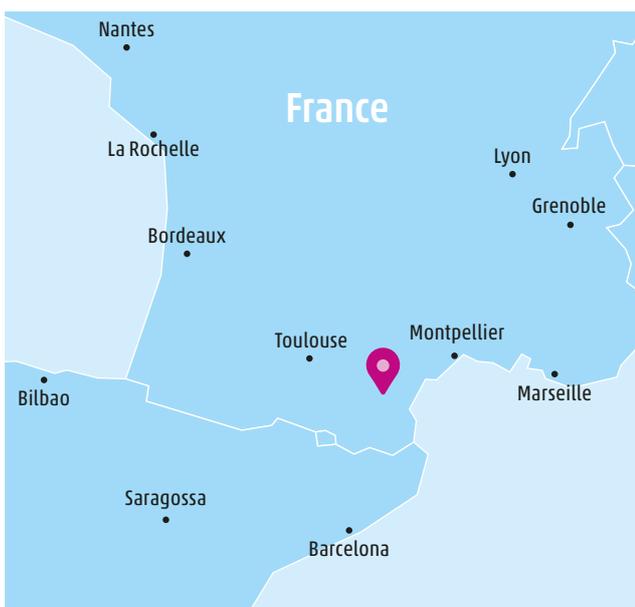
Figure 1: Location of the fire on a large-scale map.

On 24 July 2021, at approximately 13:30, a severe fire broke out in the vicinity of the city of Moux, in the South of France. A massive mobilisation of firefighting services was activated, with more than 850 firefighters, one helicopter and nine firefighting planes. In total, 850 hectares of vegetation were destroyed by flames during this two-day event; see Figure 1 to Figure 3.

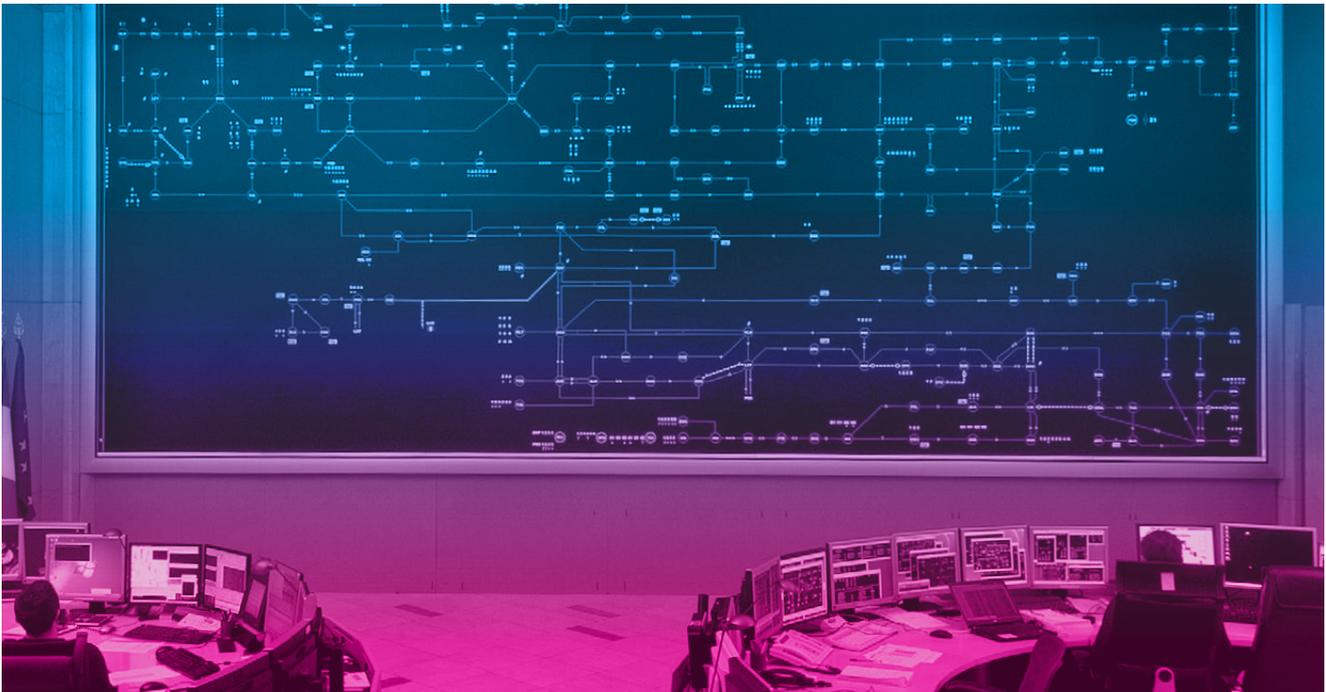
Figure 17 shows in the phase plan (phasor angle difference versus frequency) the overpassing of the so-called 'no return border' (disconnection of the Argia-Cantegrit line) that precedes the complete separation between the Iberian and French grids. Here the phase angle difference

was chosen between two substations from each area corresponding to their centre of inertia and consequently the illustrated voltage phase angle difference is representative for the transients before, during and after the system split.

Figure 17: Phase plan (angle difference, frequencies) measured in France and Spain.

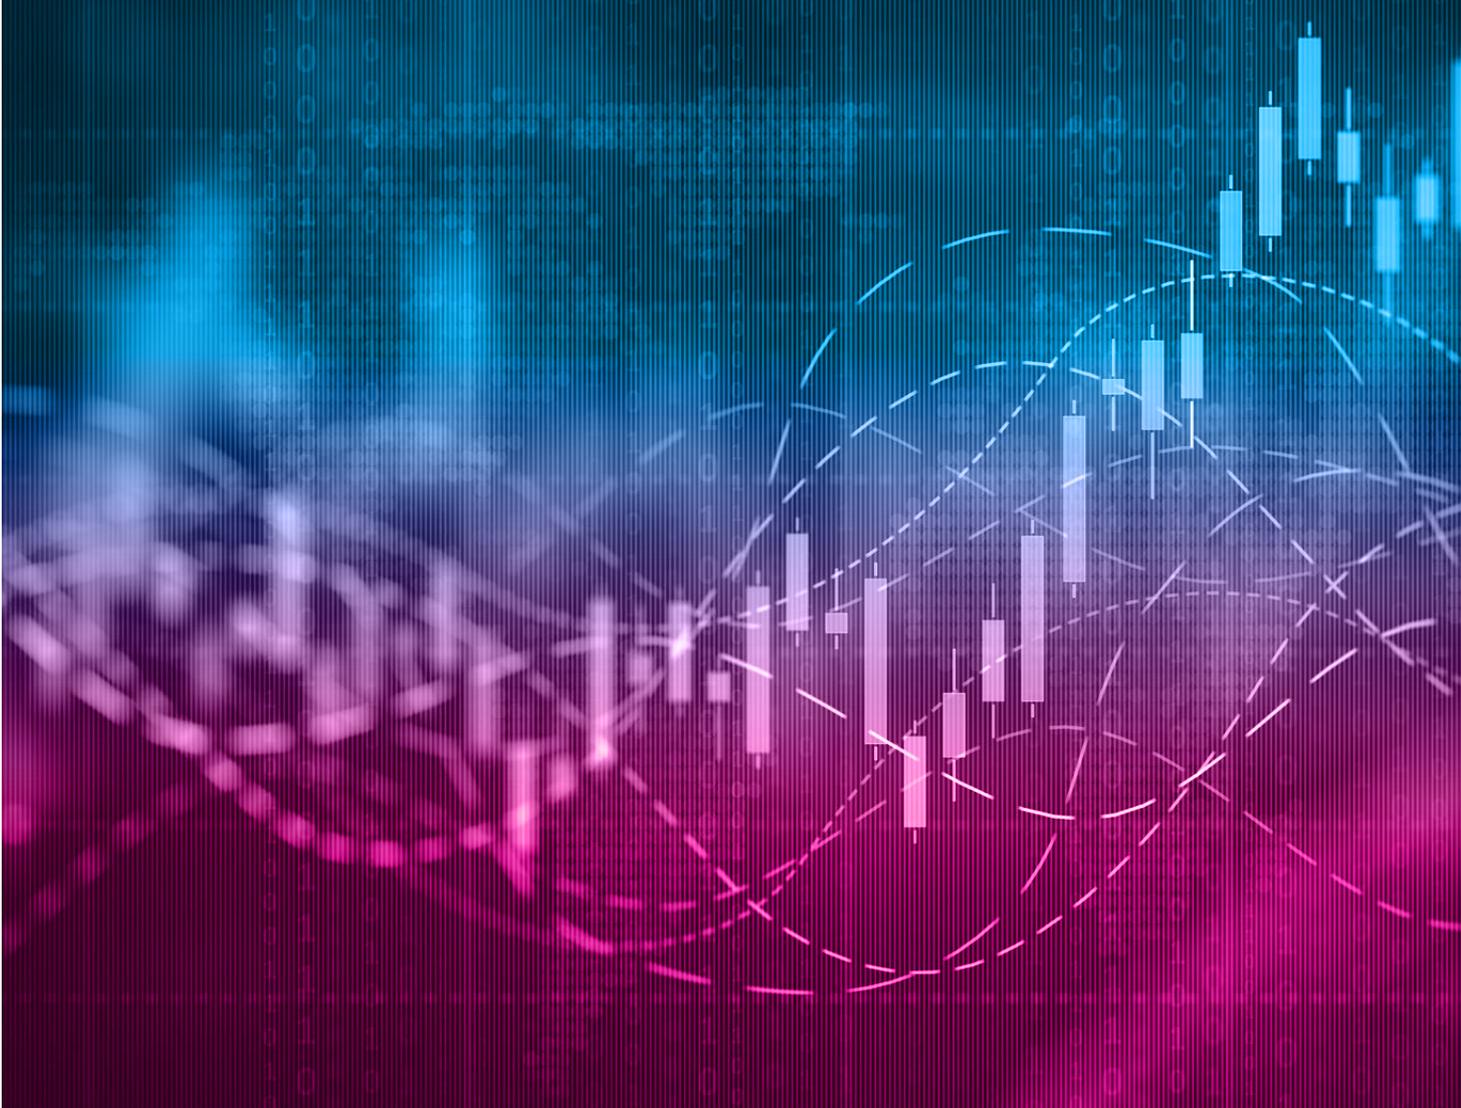
Figure 23: Simulation results (frequency) of the single busbar model and comparison with real PMU measured value (La Cereal).

In the following graphs, the model output for frequency (Figure 23) and ROCOF (Figure 24) in the Iberian Peninsula during the event (starting at event #3) is compared to the real PMU measured value.

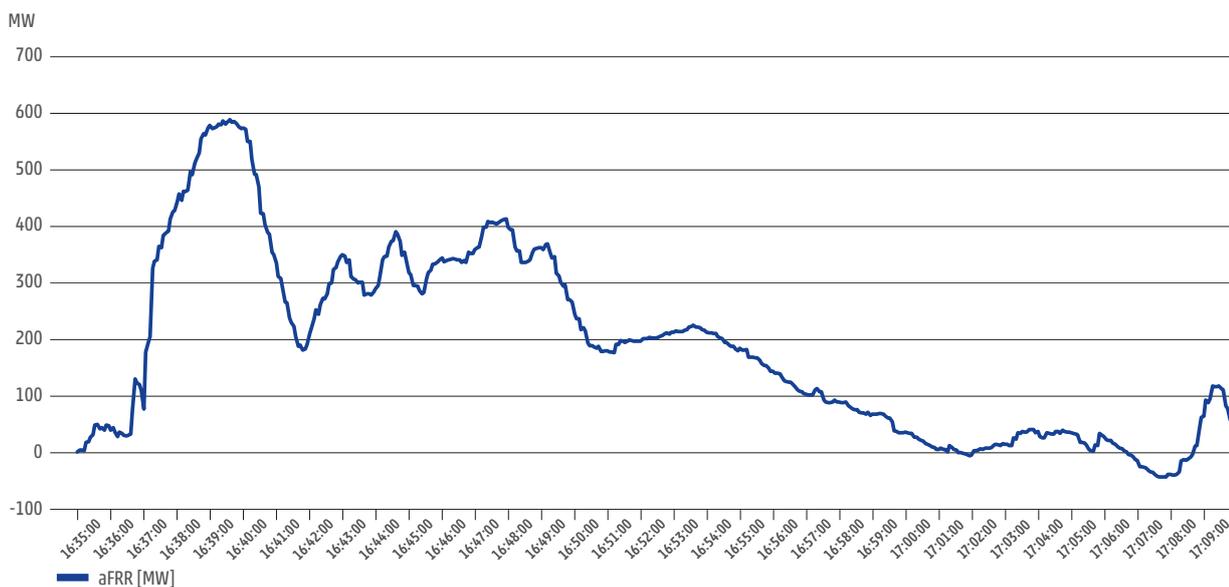
Figure 41: aFRR activation in CB Spain.

tie line Vic–Baixas remained connected, feeding the load in the Baixas node. Due to this fact, the Spanish LFC output gave a downward signal from 16:39:09 until 16:42:08, when the exchange schedule was manually set to 0. The subsequent variations of aFRR activation happened due to the frequency deviation evolution. Additionally, starting at 16:55, a downward signal was generated in the system due to the ramping of the exchange scheduled for 17:00, which was later manually corrected and set to 0. REE was the frequency leader and the resynchronization leader, according to the predicted scenario in the REE–REN agreement.
